MONITORING OF OPEN WATER DREDGE MATERIAL  
DISPOSAL OPERATIONS AT  
KENT ISLAND DISPOSAL SITE  
AND SURVEY OF  
ASSOCIATED ENVIRONMENTAL IMPACTS

Final Report To The  
Maryland Department of Natural Resources  
Water Resources Administration  
And  
Maryland Department of Transportation  
Maryland Port Administration

February, 1976

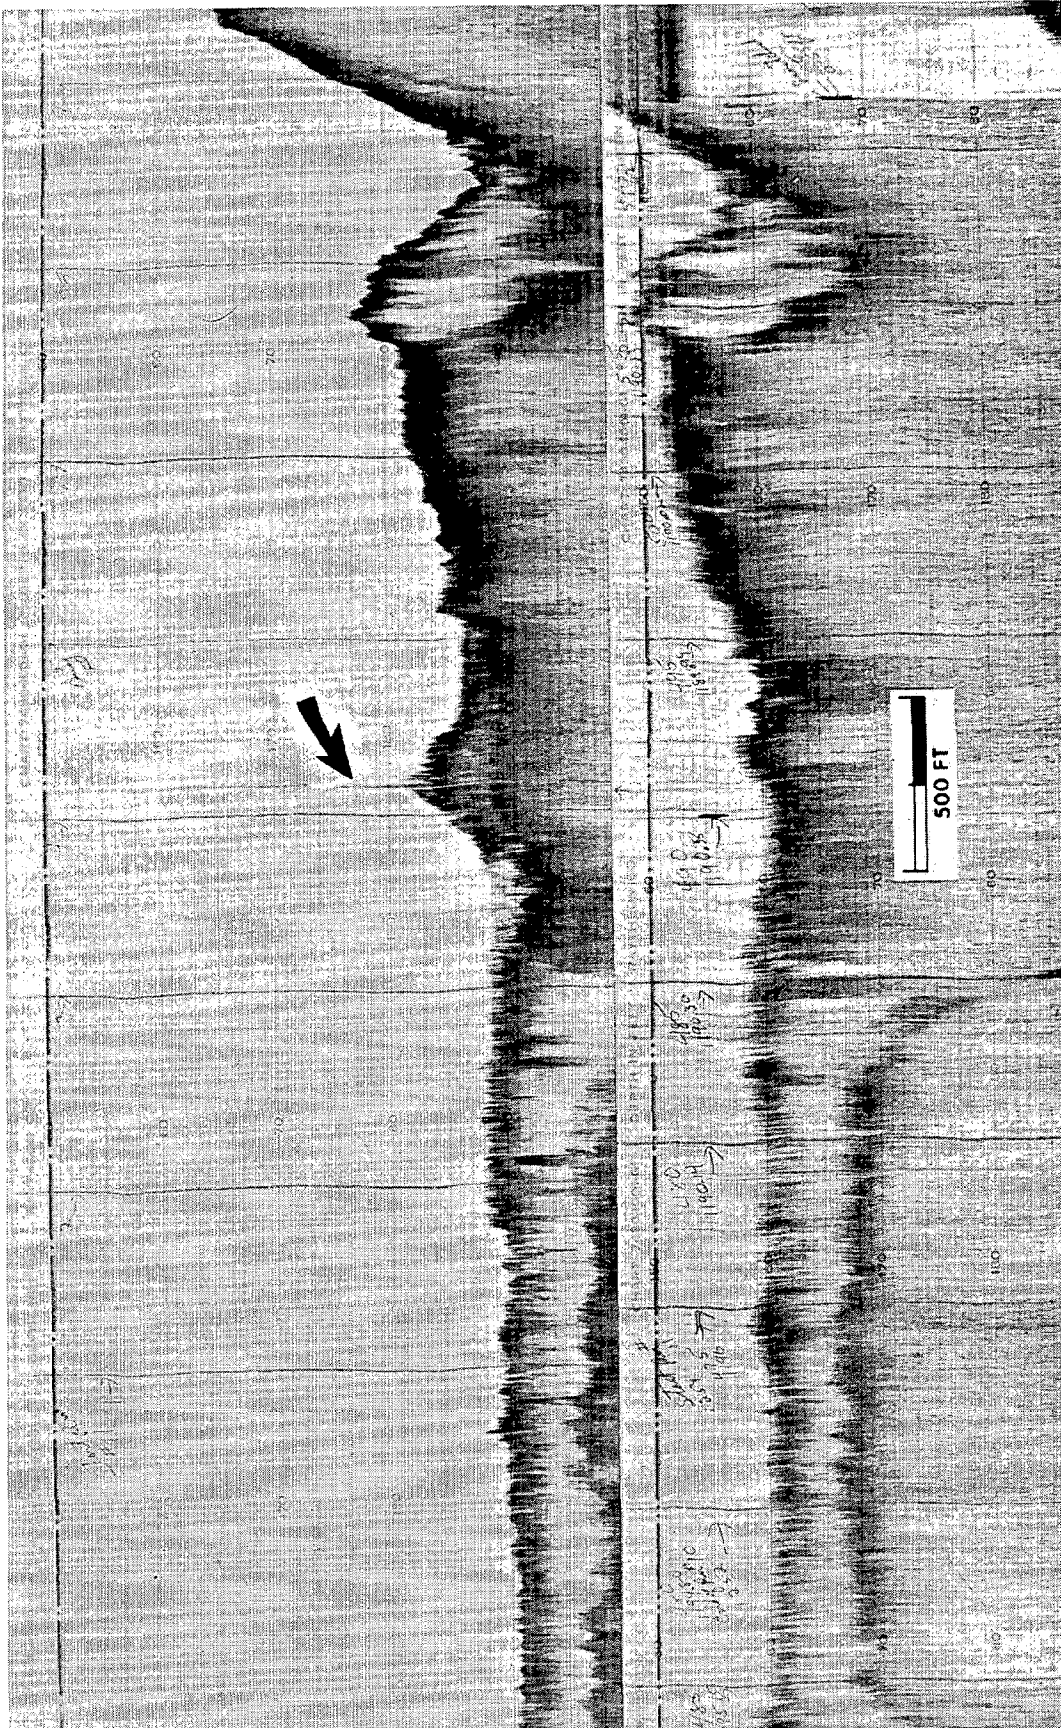
Figure III-5. Arrows show accumulations, pre-dump on bottom, post-dump, top.

Typical fathometer records showing bottom topography and deposits of dredged materials, Kent Island Disposal site.
